# Manhole Inspection Summary

Manhole # S19Y\_\_010MH

Insp Date: **6/19/08 9:59 AM**

**Location** Address: **2367 breitwert av**

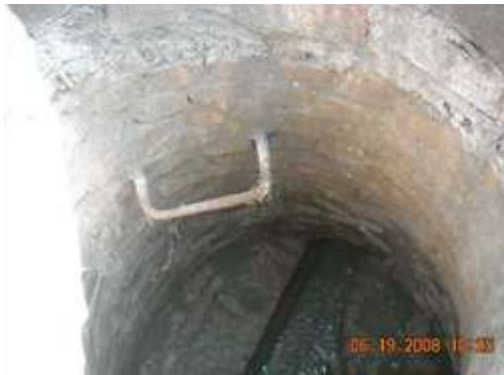
Defect 2

Count: **1** Missing: **1** ☒ **Corroded**

corroded & missing step

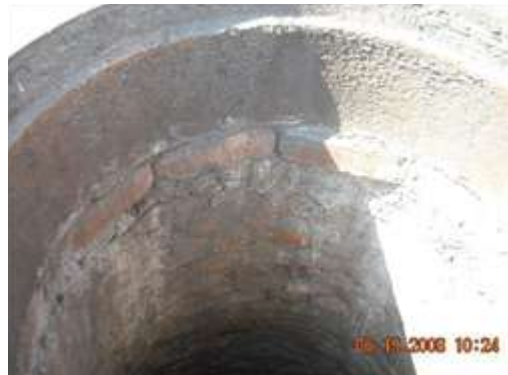
Defect 1

Infiltration: ☐ None ☐ Joint ☐ Cracks ☐ Mortar ☐ Roots ☒ **Wall**

chimney flow wall

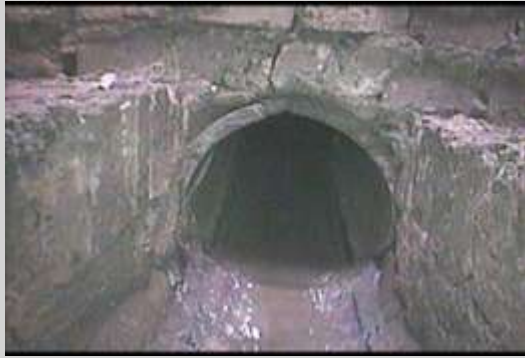
6 O'Clock Inflow

Infiltration: **None** Pipe Seal Cond: **Cracked**
